EXAMINATION OF THE SURVEYOR 3
SURFACE SAMPLER SCOOP RETURNED
BY THE APOLLO 12 MISSION

R. F. Scott and K. A. Zuckerman

1971

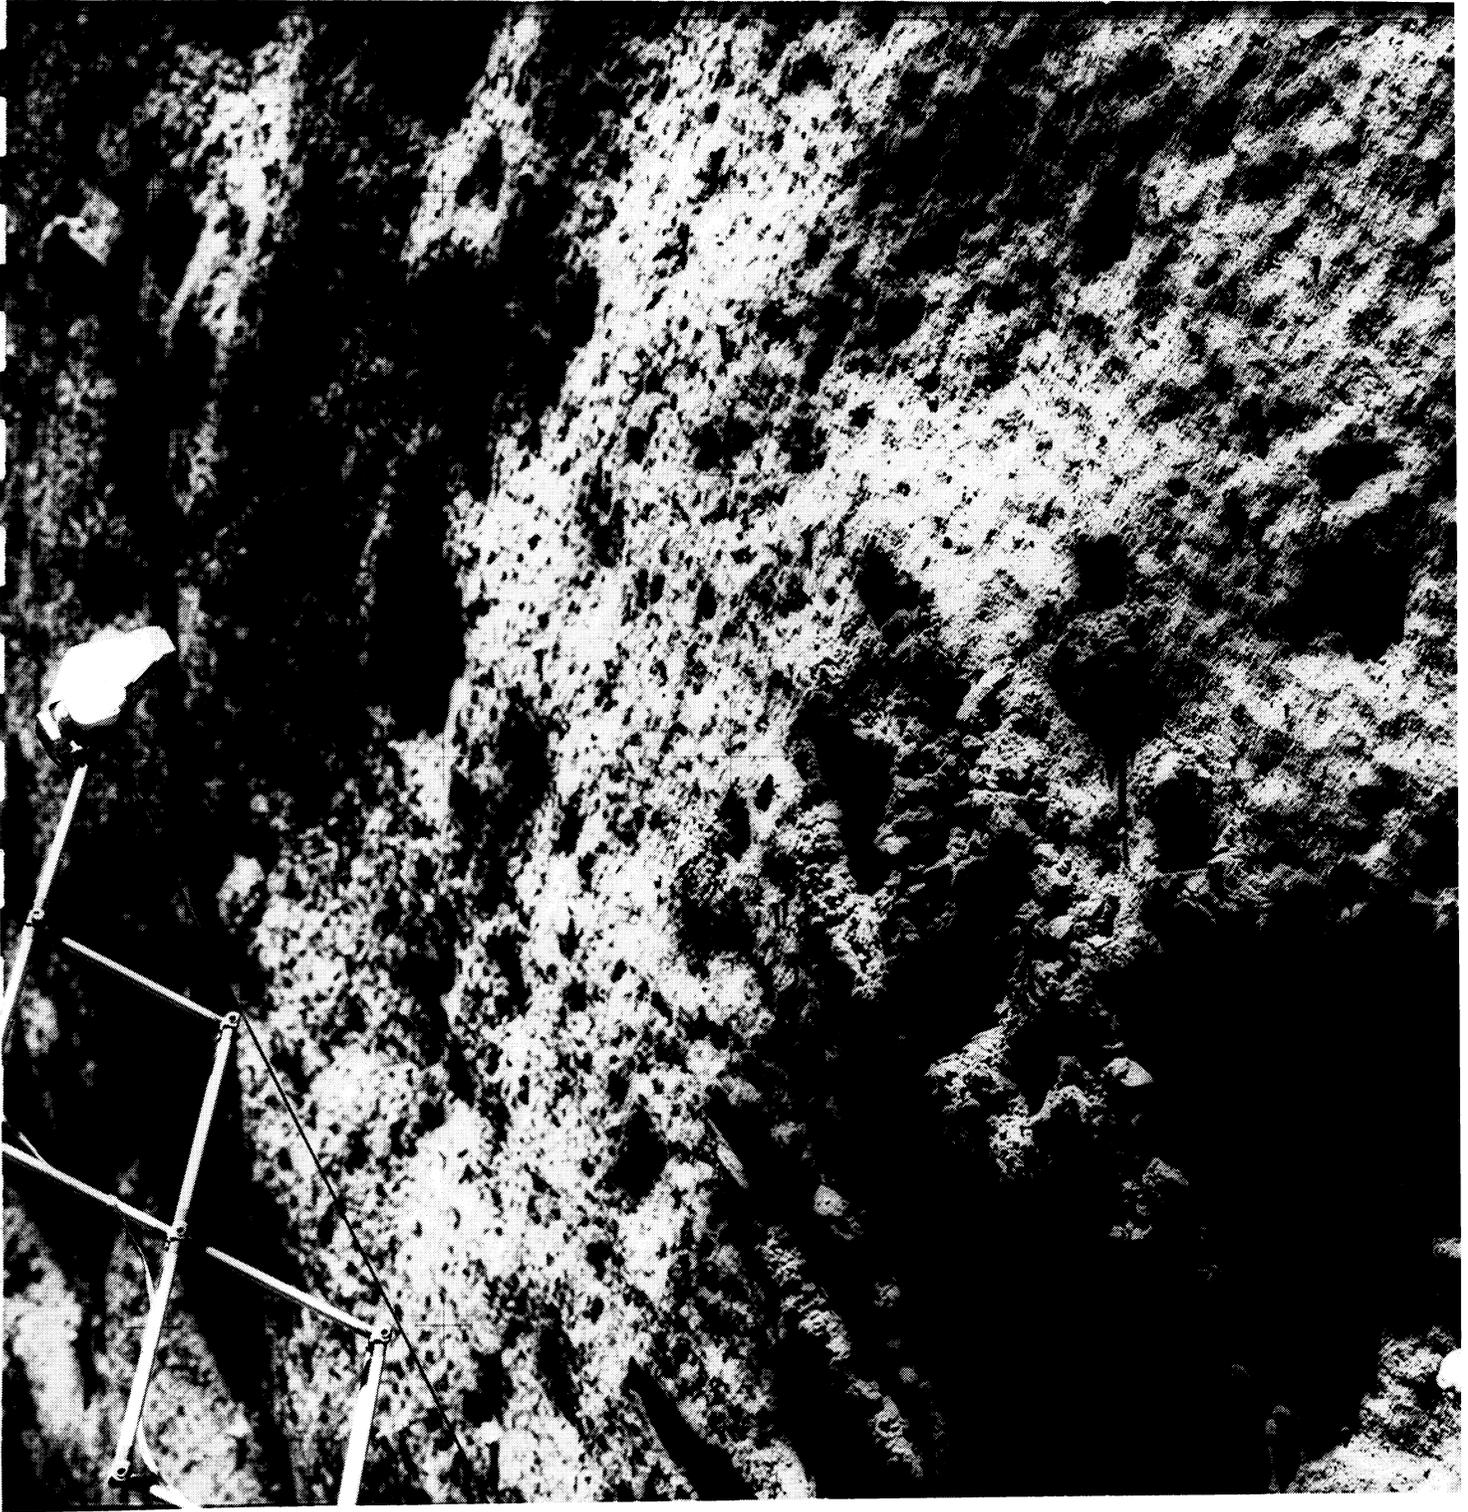
photographed, and examined. Figure 3 is an enlarged picture of the right* side of the surface sampler taken on the Apollo 12 mission; Fig. 4 shows the left side. The pictures were originally taken by the astronauts in black and white.

In the preliminary examination in the LRL it was noticed that there was a concentration of lunar soil on the right-hand side of the scoop in the area shown in Fig. 3 to be covered with lunar soil on the undisturbed scoop on the lunar surface. Possibly some of this material still represented pristine lunar surface material adhering to the scoop. Elsewhere on the scoop surface it was not possible to identify on the astronauts' pictures areas of definite soil cover which could be correlated with the scoop appearance and soil coating at the time of the initial examinations.

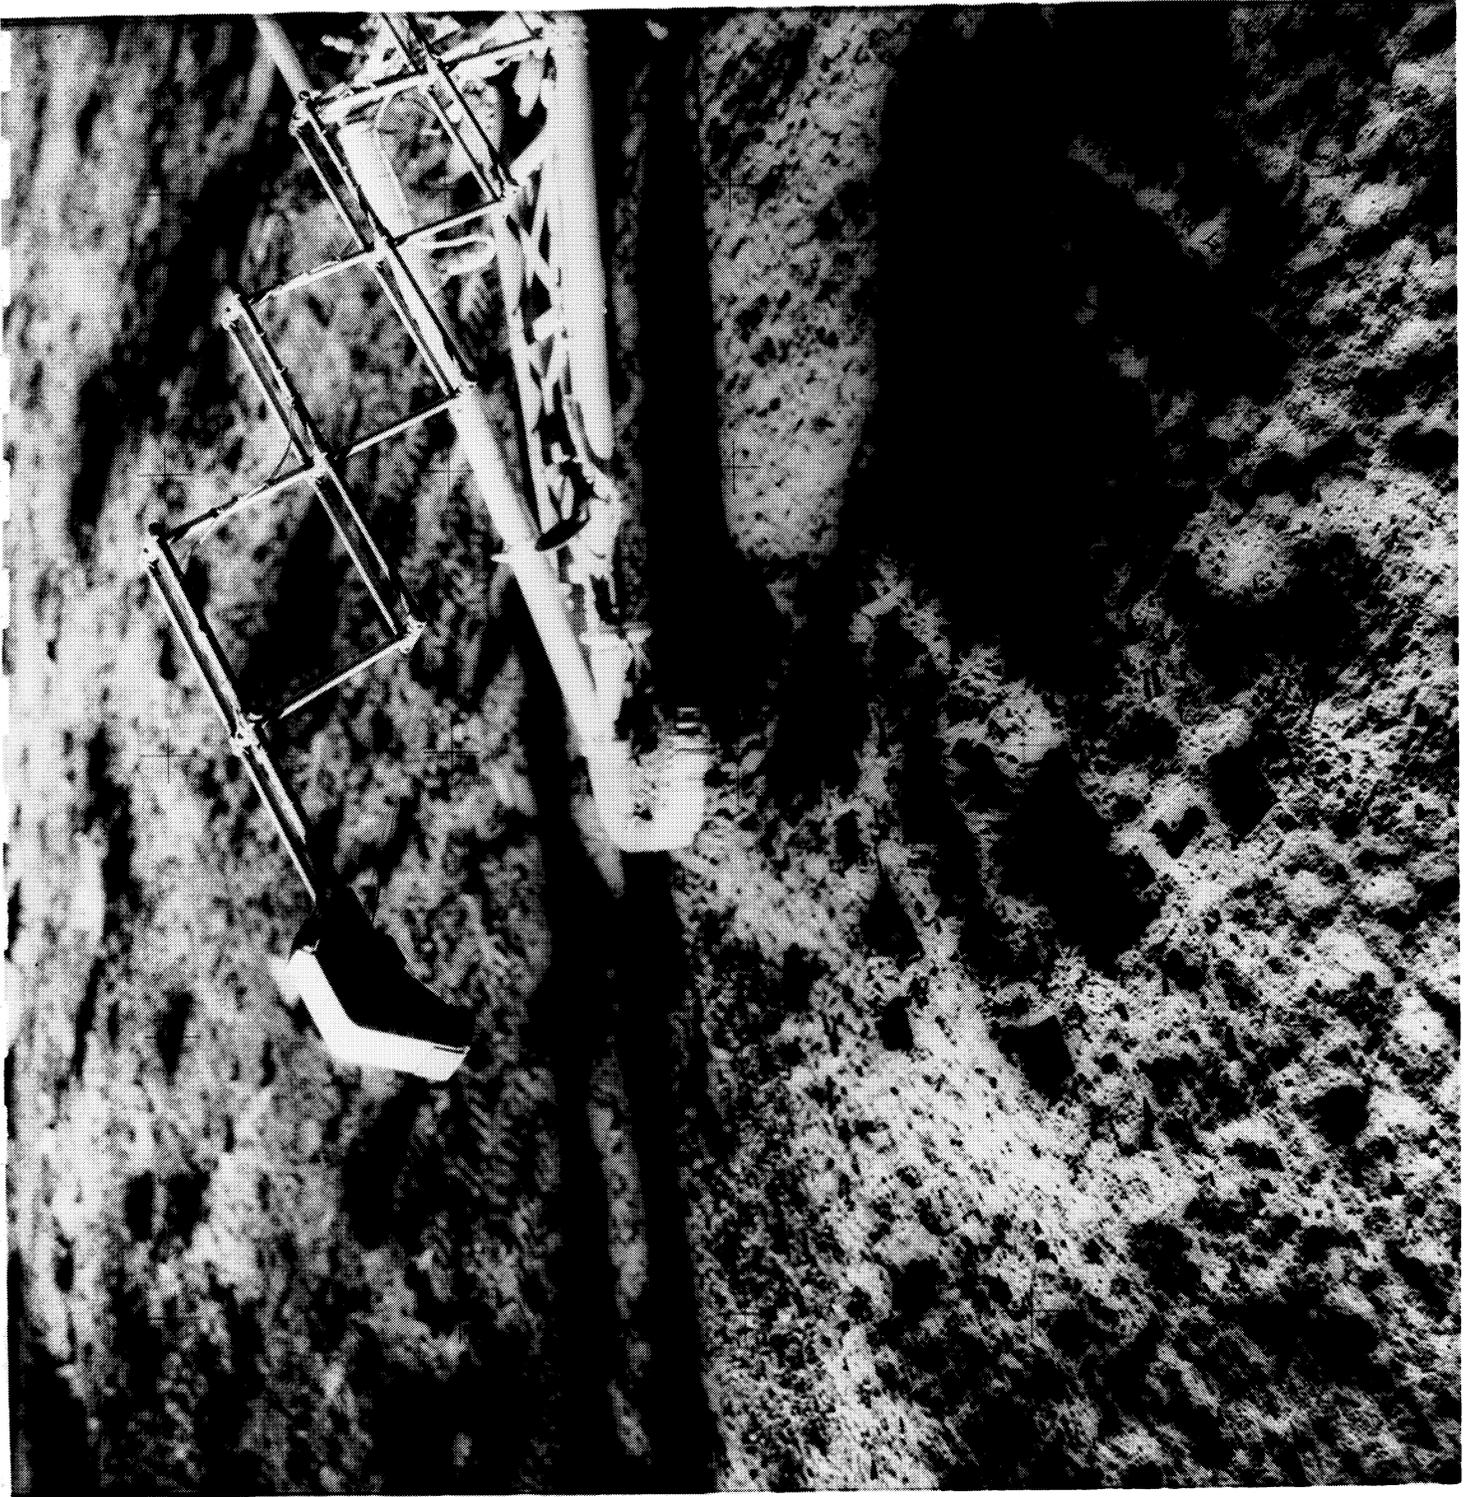
Fig. 4

but is less clear than shown in Fig. 4. Possibly the illumination condition of Fig. 4, as well as the soil-coated condition of the returned scoop, made the contrast between the tanned and less tanned zones not so obvious. It seems likely that the blotchy appearance of the grooves or dents on the upper surface of the scoop, as seen in Fig. 22 for example, developed from an accumulation of some lunar soil in the bottom of the grooves, with a resulting protective action.

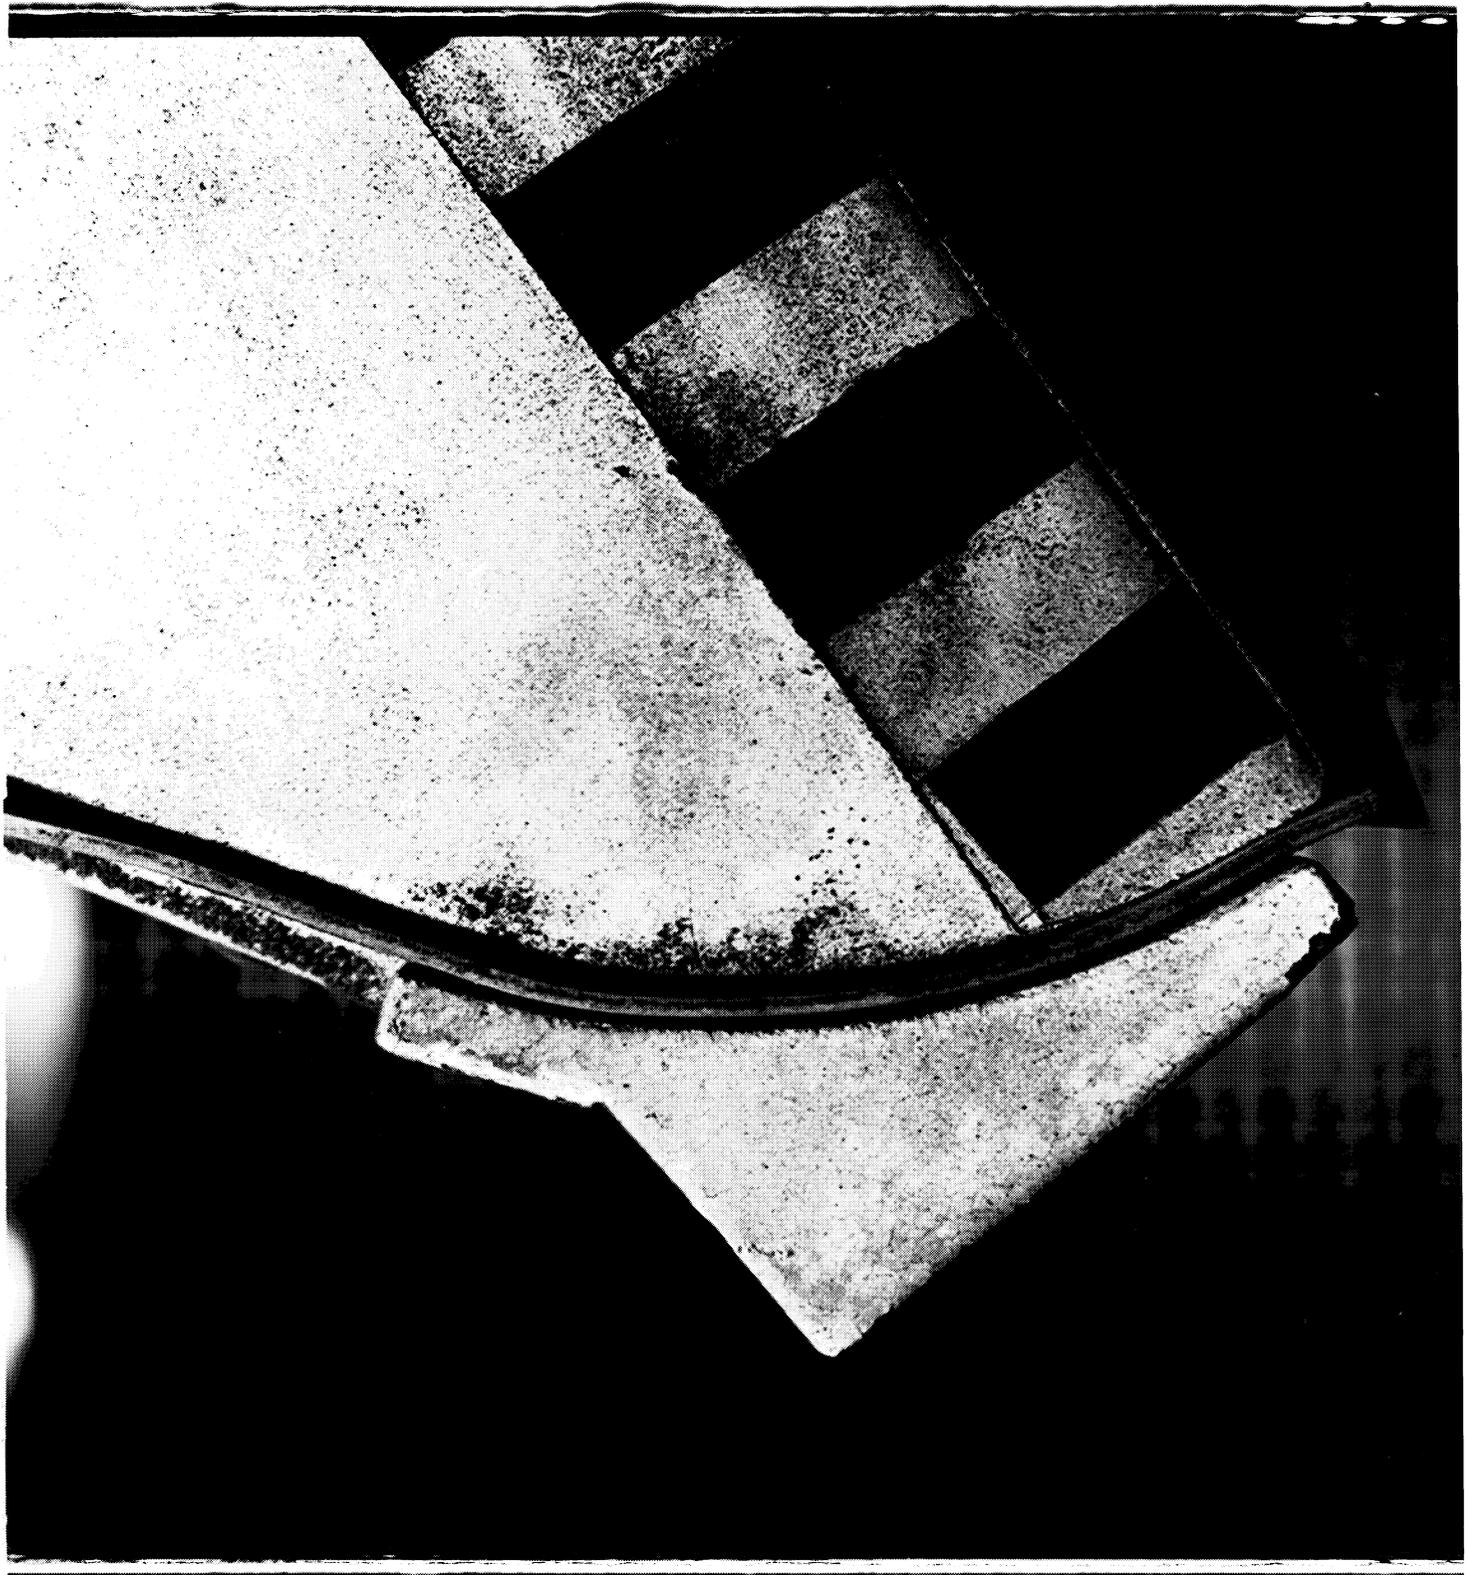
Fig.7

Coloration patterns on both the right- and left-hand sides of the scoop are shown in Figs. 7, 18 and 20 in black and white and natural color; the

A second item of interest concerning the painted surface is the crazing or cracking of the paint on the sides and base of the scoop door. Polygonal fracture patterns are apparent in Figs. 5,6,7,23 and 24. This portion of the scoop was made of a glass fiber-impregnated resin coated with the standard paint. The fracture pattern does not appear on the painted metallic surfaces of the rest of the scoop, and may therefore be related to the different thermal conduction and expansion characteristics of the paint, the resin and the metal. It is also possible that radiation damage to the paint could have resulted in volume changes in it. In this case, the appearance of fracture patterns on the scoop door would be related to either the different thickness of the paint or different nature of bonding of the paint to that surface as compared with the other metallic surfaces. The chipping of the paint from the scoop door tips indicate that the bonding between the paint and the resin was weaker there than elsewhere, since paint at the edges of the scoop body was equally subjected to contact with the lunar surface. A careful study of the Surveyor 3 television pictures was inconclusive as to the presence of chipping or flaking at these points during the lunar surface operations in 1967. Observations during handling of the returned sampler indicated that the paint at the corners of the scoop base chips quite easily. Fragments of paint were observed in the lunar soil which was collected from the inside and outside of the scoop.

Even a cursory examination of the returned scoop shows that it has been subjected to a considerable amount of scratching and abrasion. Some of the typical larger scratches are apparent in Fig. 7, and photographs made at higher

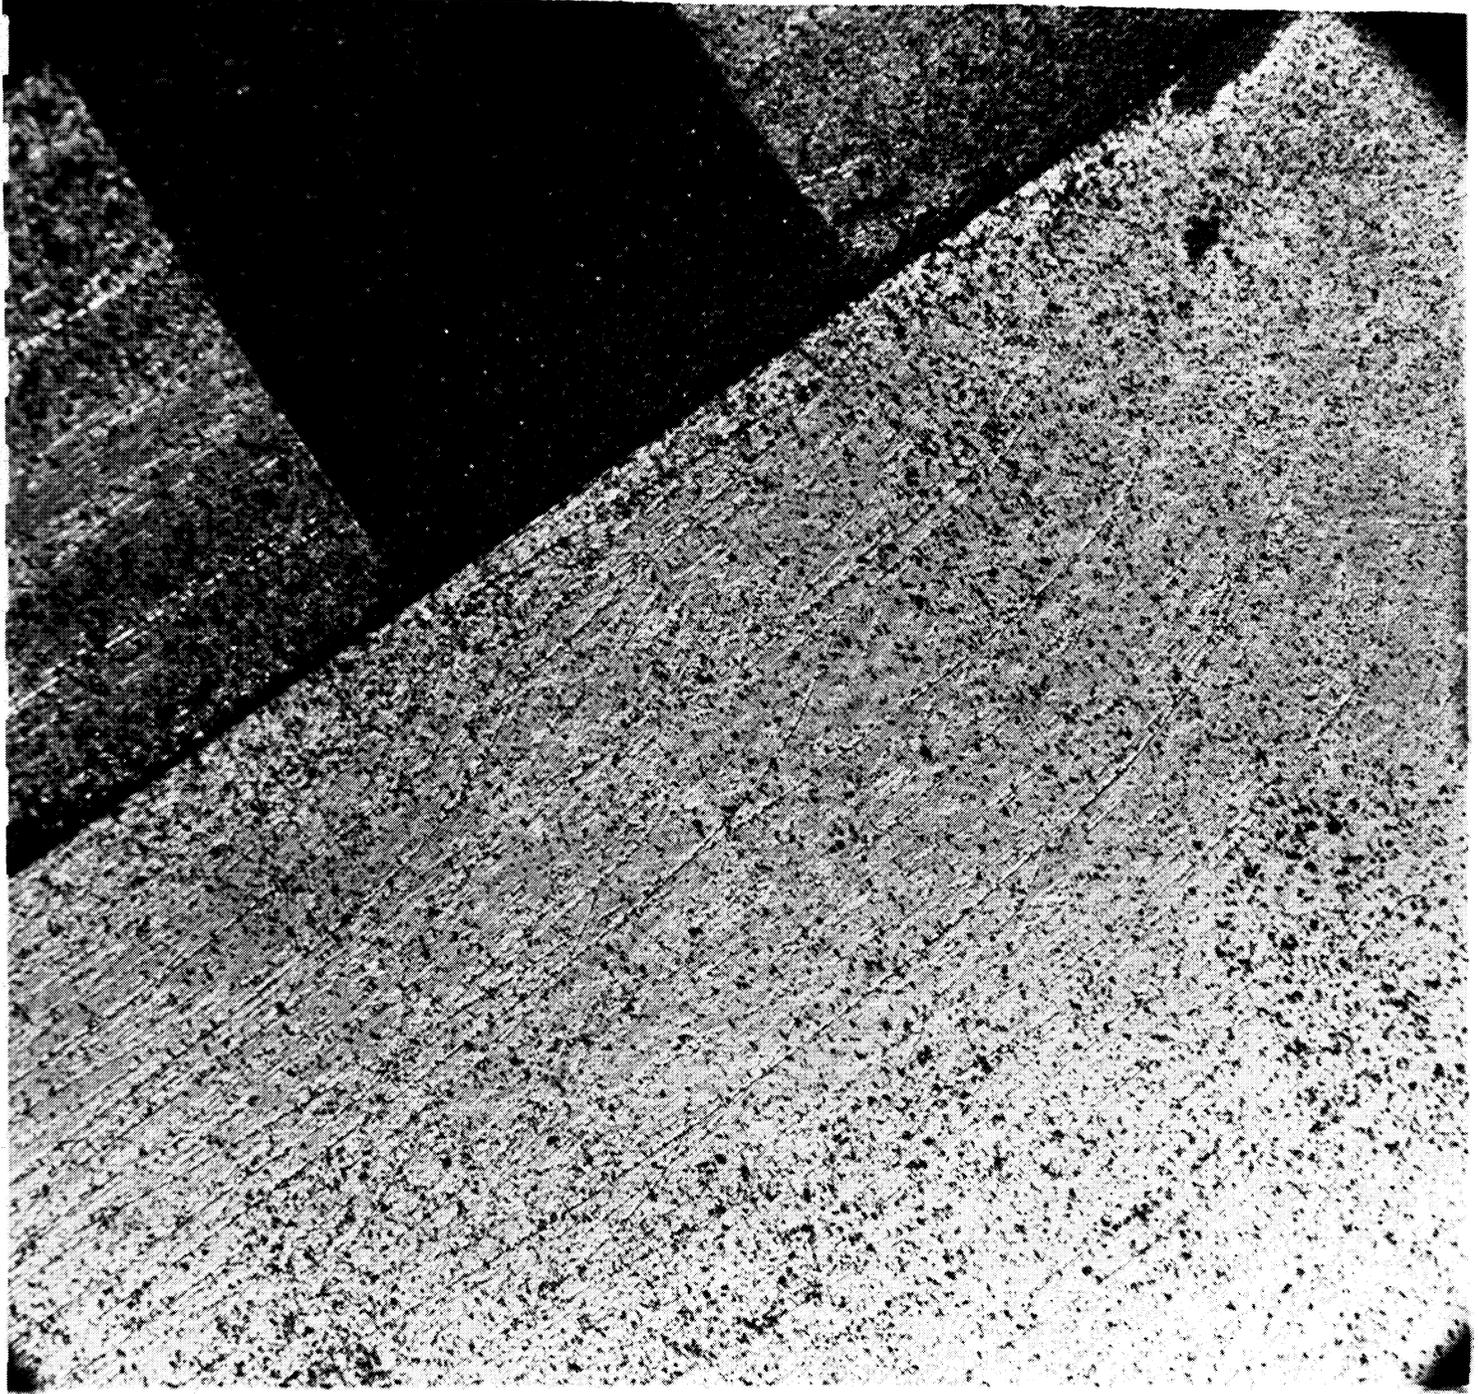
Fig. 9

magnification show them clearly. For example, a pair of pictures at a magnification of 11.5 illustrates the condition of the laboratory scoop (Fig. 8), in comparison with that of the returned scoop (Fig. 9) in the same area of the surface. The terrestrial scoop has been employed in a variety of soil testing operations in a number of different soils on earth, and it is observed in Fig. 8 that the general effect of this soil contact has been to smooth down the irregularities in the painted surface without the development of scratches. Considerably less soil contact took place with the Surveyor 3 scoop, but it is evident, as shown in Fig. 9, that its surface has been abraded. A general smoothing of the surface of the paint is also evident in Fig. 9. An undisturbed painted surface close to its original condition is shown in Fig. 14 (the laboratory scoop gear box) which demonstrates the rough nature of the surface developed by the spray painting process. It was initially thought that the scratches on the Surveyor 3 scoop formed in lunar surface operations but it has since been learned that the painted surface of the scoop may have been lightly sandpapered (and in places repainted) prior to launch to remove defects. Some months after the initial examination of the Surveyor 3 scoop, it was disassembled for study of the individual components. When this was done, it was found that the inside surface of the scoop presented an appearance essentially identical to that of the laboratory scoop in Fig. 14. Since the inside had been subjected to almost as much sliding contact with the lunar soil as the outside, it must be concluded that the lunar material has not substantially abraded the painted surface and the scratches visible in Figs. 7 and 9 result from

Adhesion of the lunar soil to all surfaces of the returned scoop is readily apparent in Figs. 9 and 11. Even the teflon seal of the scoop door is seen to be heavily coated with lunar soil particles in Fig. 11. The lunar soil scattered about the surface sampler during and following its return to earth appears to adhere differentially to the different surfaces of the sampler. The most obvious observation is that the lunar material adheres more readily, in order, to (1) painted, (2) Teflon, and (3) metallic surfaces. Figures 12 and 13 show for comparison the operating mechanism of the scoop door of the terrestrial sampler, and the same area of the Surveyor 3 sampler door. It can be seen that lunar soil is adhering to the painted surface of the door in considerable quantities whereas the metallic surface, the screw heads and the door axle are all relatively free from lunar soil. It should be noticed, of course, that the metallic surfaces are not absolutely clean. It was not possible to tell in a superficial examination if there was selective adhesion of various components of the lunar soil, except in the case of glassy spheres, as noted later. In Fig. 13, adhesion of the soil to the Teflon can also be clearly seen, as well as a slight color change of the Teflon itself. The Teflon appears slightly brown on its outer edges shading to the original milky white next to the metal part of the scoop door. It is apparent that

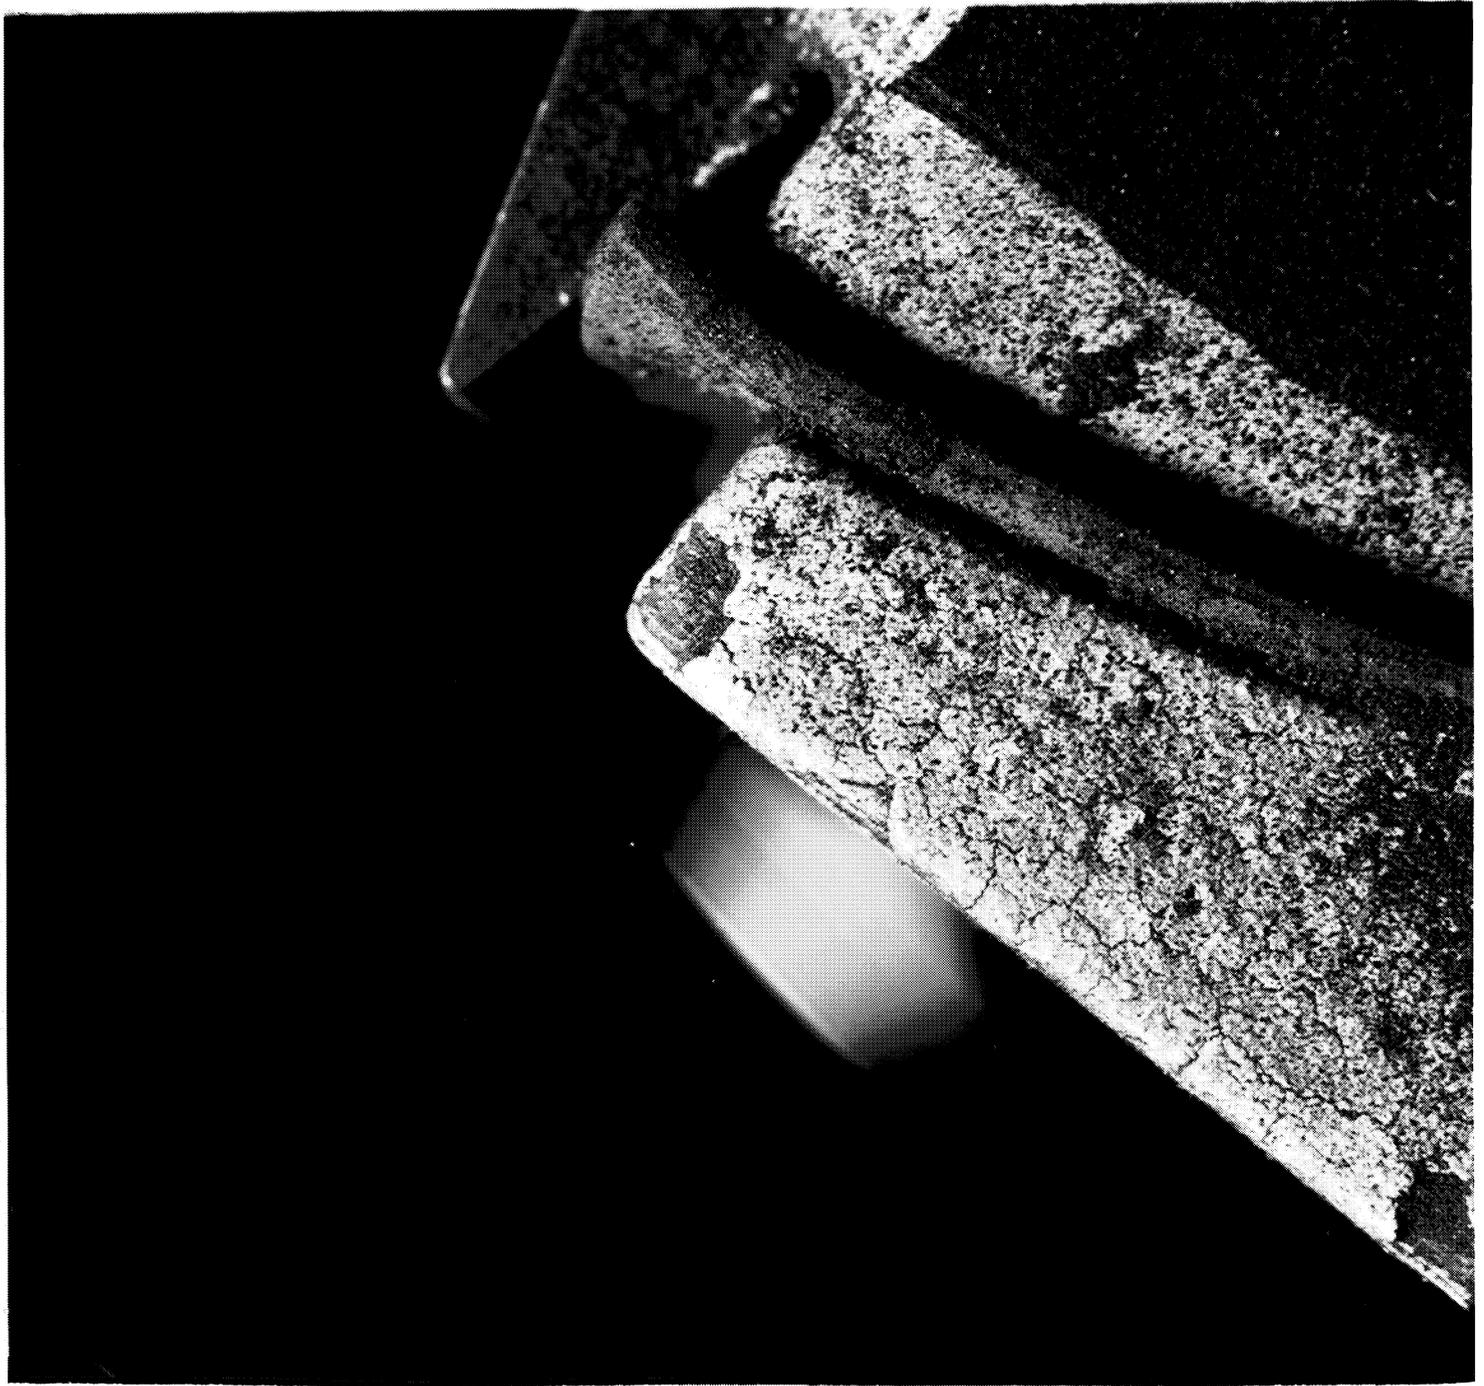
Another comparison of the two surface samplers is shown in Fig. 10 (laboratory) and Fig. 11 (Surveyor 3 scoop) in which it can be seen that terrestrial operations have also resulted in the removal of paint chips from the side of the scoop tip, and that some crazing of the paint in this area has also occurred.

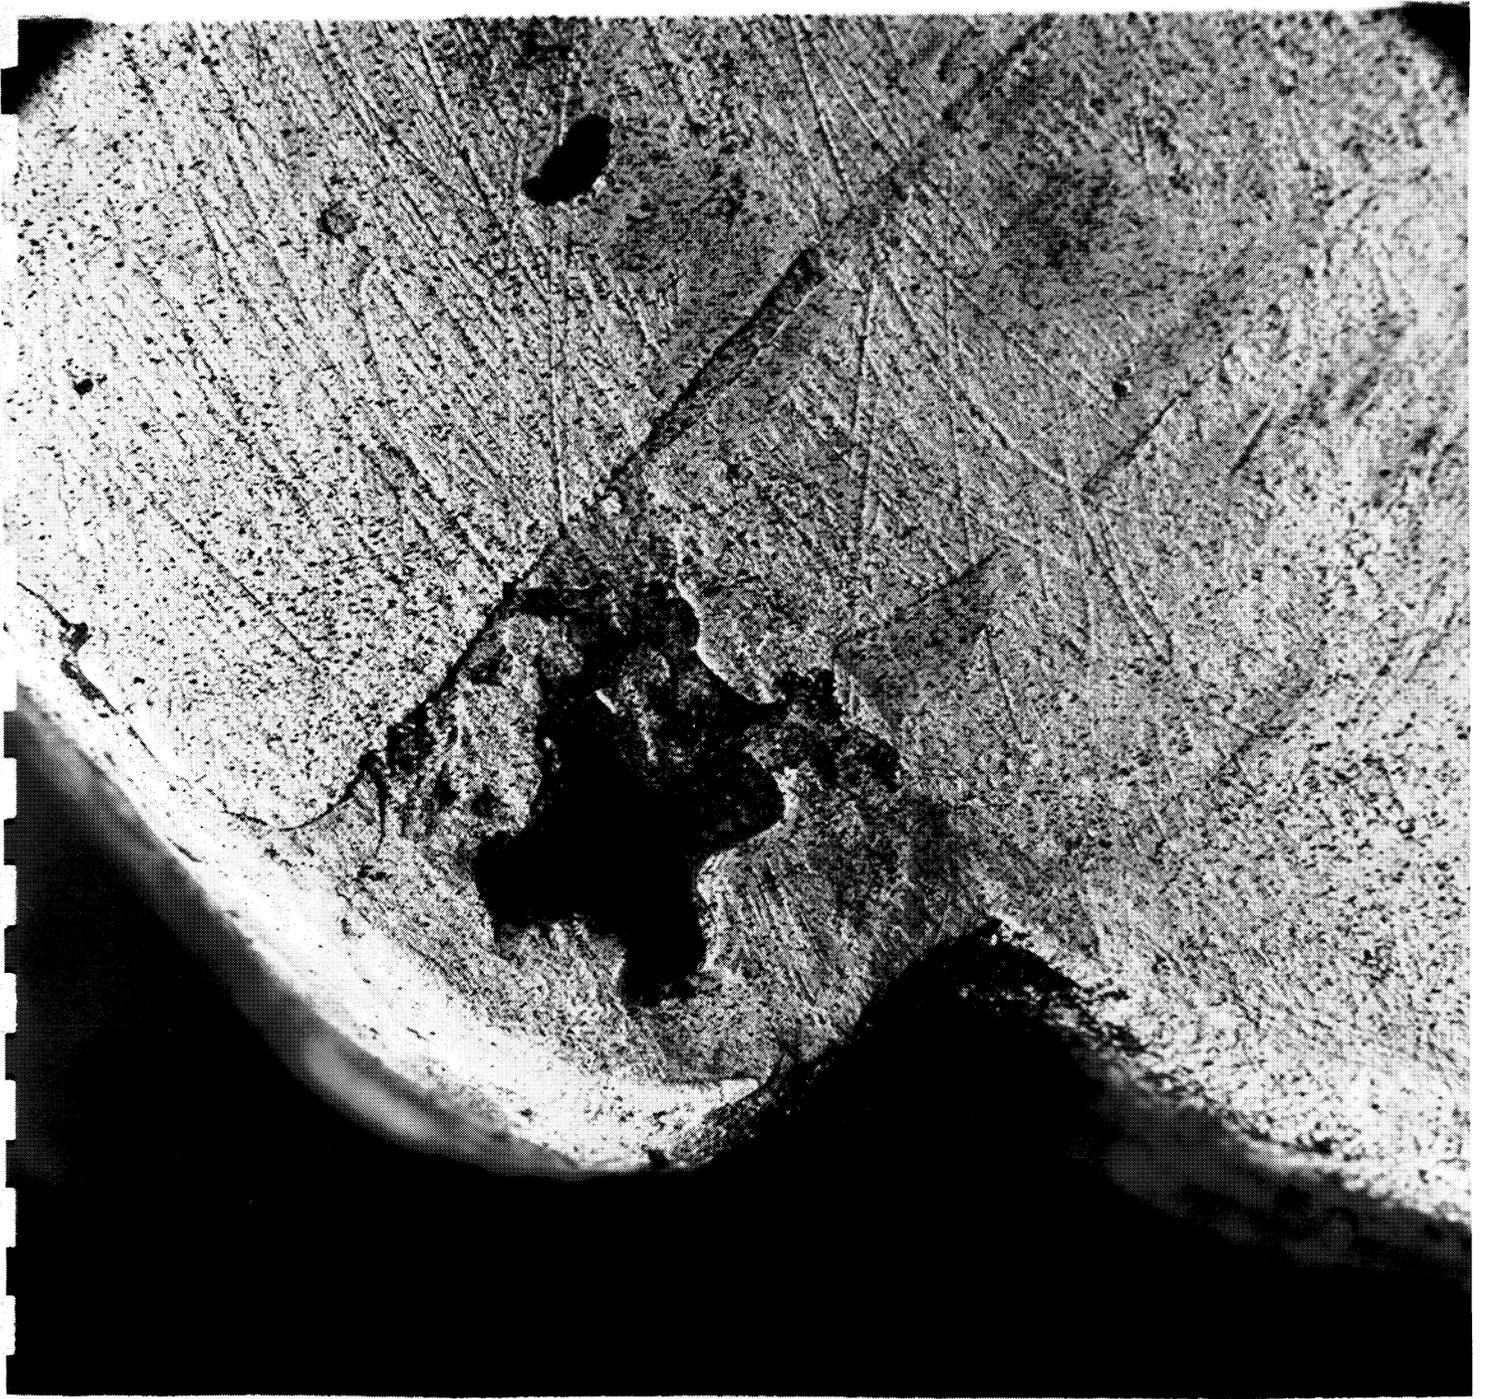
In spite of the considerable amount of contact with a variety of soils in laboratory bearing tests and trenching work, the surface of the gear housing (Fig. 14) of the terrestrial sampler exhibits almost the original appearance of the painted surface. The strong contrast between this and the lunar sampler is evident in Fig. 15. It is evident in Fig. 15 that the gear box had been repainted prior to launch a number of times.

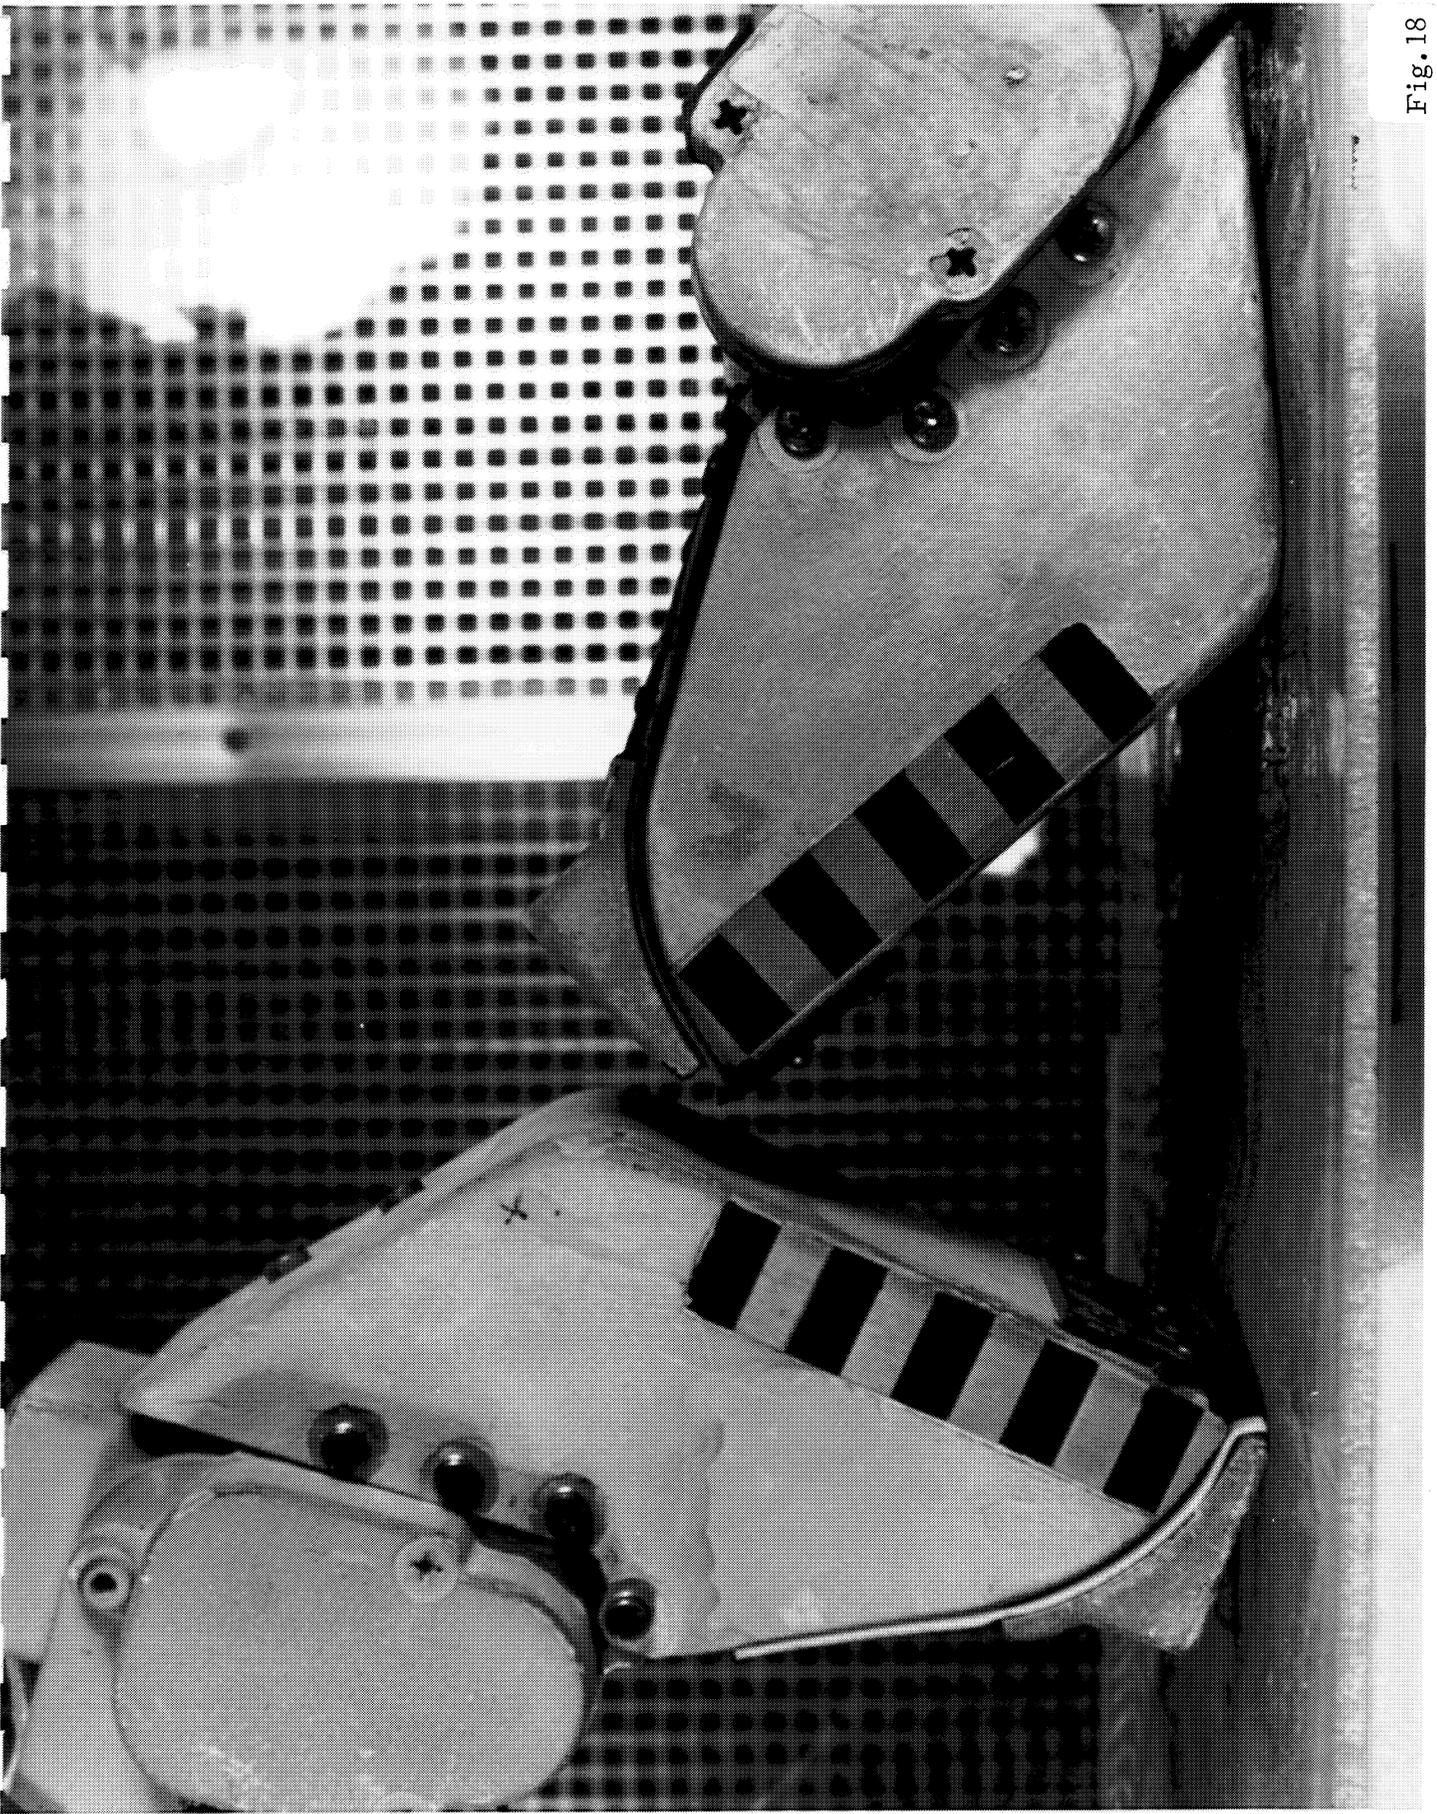
Fig. 18

A visual examination of the scoop as shown by a comparison of Figs. 18 and 20, indicates that the intensity of tan coloration is greatest on the upper surface of the scoop, less on the sides, and still less on areas which have been shaded to some extent. Although a detailed examination of this point has not been made, it appears that the degree of alteration of the painted surface is related to the duration and angle of surface exposure to the sun on the lunar surface. Even the base of the scoop, which was exposed to some solar radiation in the lunar morning, has been changed somewhat in color, as seen in Fig. 23. On the left-hand side of the scoop, (Fig. 4) a pattern of color is apparent, wherein the tip of the scoop appears lighter than the rest of the area on this side. This effect is still observable on the returned scoop,

In Fig. 19 the brown color change which is apparent on earlier pictures, such as Fig. 18, appears as a dustier pink, contrasting to the lighter bluish pink, for example, at the scoop tip where the sampler was protected by lunar soil. It is not known why the shading pattern on the side of the returned scoop is apparent; it may be related to the abrasion of the surface during bearing and trenching tests. In the picture, the light blue-green flecks which appear on both scoops and on the table on which they are resting are fluorescent pieces of organic material which were present in the laboratory. They were probably derived from a variety of fabrics which were present.

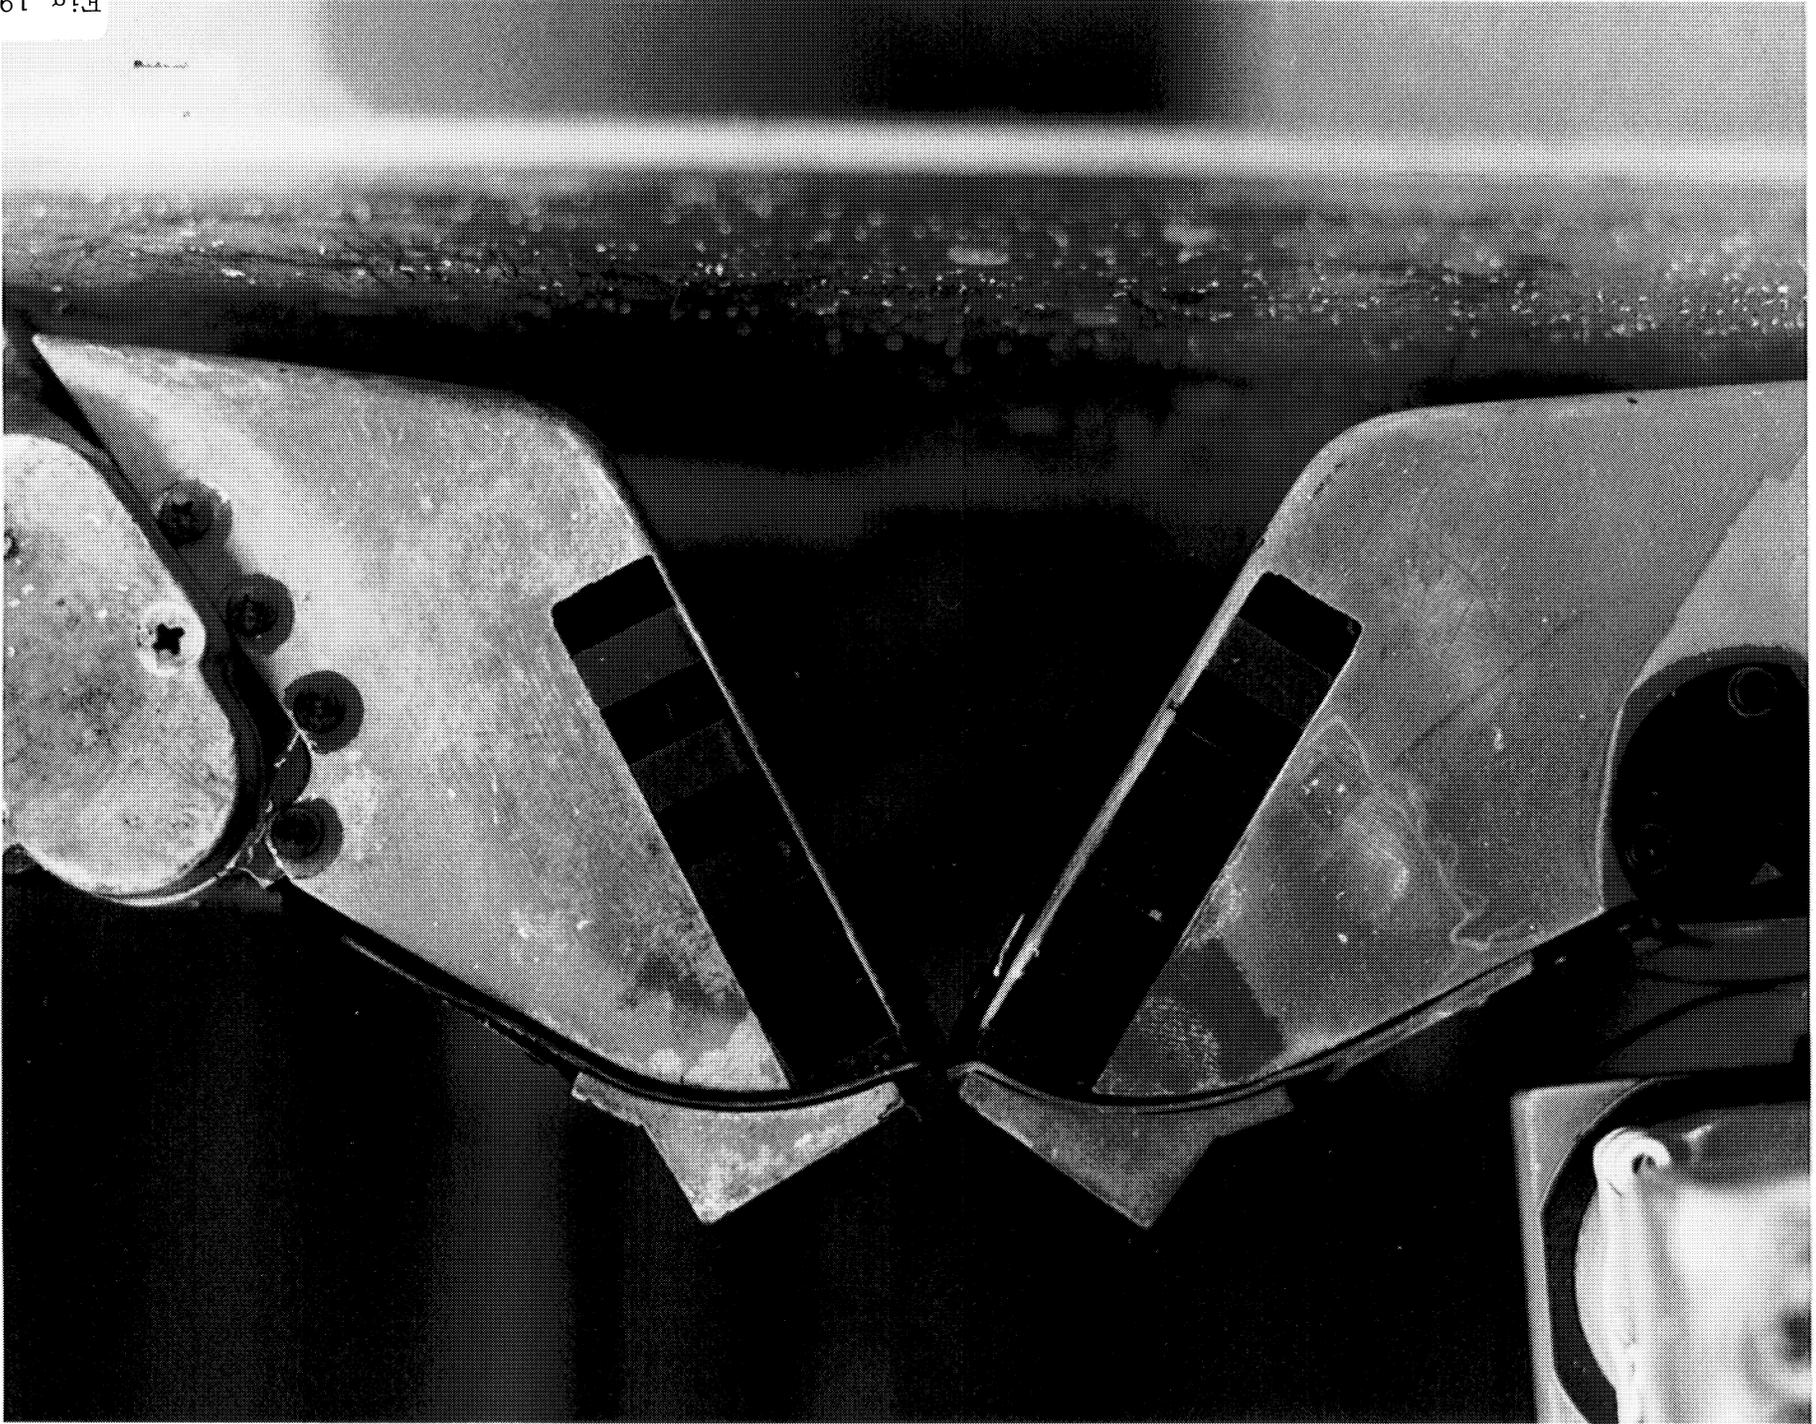
Fig. 20

The most striking change in the appearance of the samplers can be observed by comparing the tops of the two scoops in Figs. 20 and 21. The brown coloration of the returned scoop is deeper on the upper surface, and this is made even more apparent by the photograph (Fig. 21) in ultraviolet illumination. At the bottom of the housing which covers the scoop door motor, a yellow region is seen in Fig. 21. This is probably due to irradiation of a spill of the epoxy coating which was applied to the terminals of the wires for protection, since it does not appear on the laboratory sampler to which no epoxy was applied. Alternatively, it may be the result of the irradiation of this part of the scoop which was altered by heating when the wires were soldered in place. The upper surface of both scoops is shown in Fig. 22 in which it is seen, as remarked earlier, that some protection to the paint was
